### Brad Cockrell's Farm, Mooka Flats - Mercer

#### FOR HIGH JakMat RACE STABILISATION **PRESSURE ANIMAL** www.jakmat.co.nz **TRAFFIC AREAS** 'We haven't had any pitting at the high traffic area and there has been no maintenance since laying of the JakMatDairy" Brad Cockrell, Mooka Flats - Mercer Herd of 800 cows, (775 square metres laid) JakMat installation After 8 months usage Honeycomb design Very low ongoing maintenance Reduced risk of lameness for ultimate strength No more potholes and less • Enhanced cow flow and material retention Lay between milking carry over to shed

## Case Study: Dairy Farm Albert Pouwels, Morrinsville

# Case Study: Dave Wilson's Farm, Winton Southland

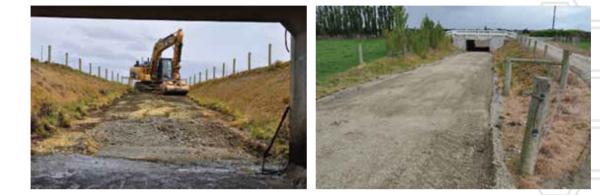
Remove overburden, apply GAP20 base aggregate and roll

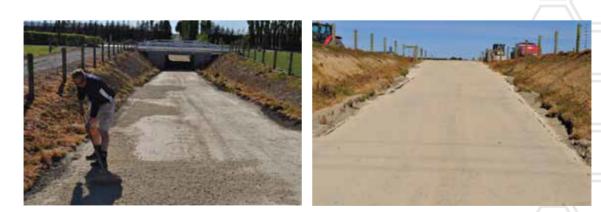
Fill the mat with Milburn Lime 20mm and compact

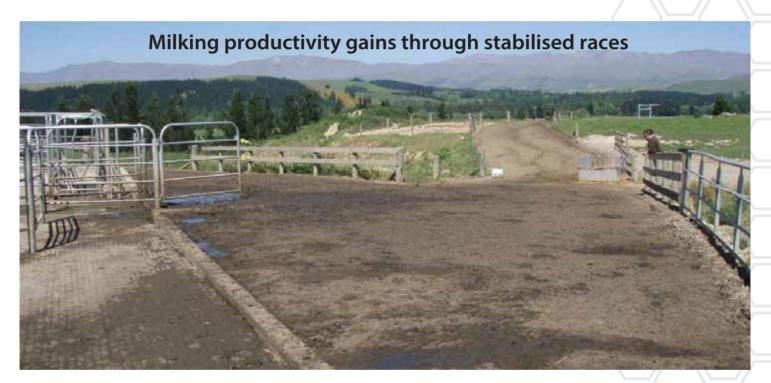
(JakMats laid in Winter 2010)

The main problem area was the transition from concrete to race, where potholes were building in wet weather making cows reluctant to step onto the race. Due to jammed exit areas milking had to be interrupted to push the cows out of the shed, resulting in decreased milking efficiency.

This drove Ryan to lay down a geotechnical product called JakMat Dairy onto his race. This honeycomb cell provides races with additional stability and improved drainage. Ryan laid the product down together with his staff, covering 150m2 in the transition zone from concrete to race.
